# IBM FlashSystem V840

## Firmware Version 1.1.2.7

### Release Notes

October 10, 2014

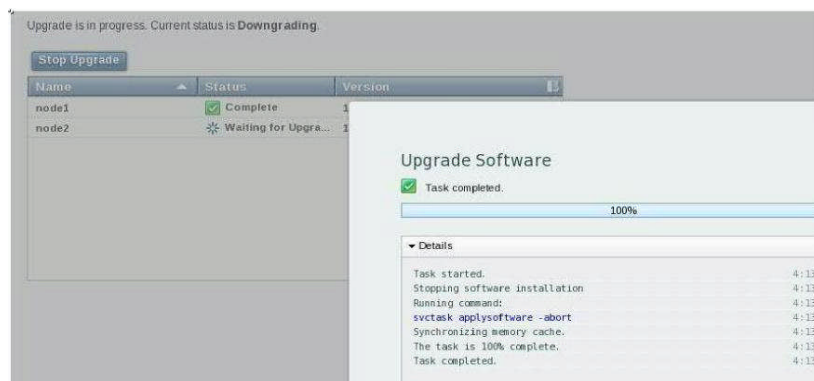
**Figure 2.** Aborting the upgrade after it has stalled

If the upgrade takes more than two hours to complete, it may have stalled. Upgrade status is viewed by issuing `lssoftwareupgradestatus` CLI command. In most cases, this can be resolved by aborting the upgrade and reattempting the upgrade after the system downgrades to its original level. To abort the upgrade, issue the `applysoftware -abort` CLI command or click the “Stop Upgrade” button in the GUI, as seen in Figure 1 below.

After the system is downgraded, you can reattempt your upgrade from the GUI or CLI. If the upgrade stalls repeatedly or if you have alerts which cannot be cleared, contact IBM Support. Support contact information is provided in Section 6.0 of this document.

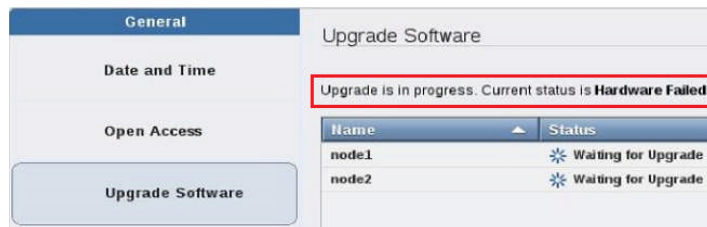
Figure 3. Viewing the upgrade status

If the upgrade has failed or stopped due to a hardware failure, you will see the "Hardware Failed" status as presented in Figure 2 below.

If you suspect a hardware failure, you can issue the `lssoftwareupgradestatus` command to confirm the state of your system. This command shows that the system is in a "hardware\_failed" state, and that the event log contains a "System upgrade suspended" event. You may resume the upgrade by issuing the `applysoftware -resume -force` command for the following conditions:

- PSU Unsupported events
- Battery fault type 1 faults that are fixed and online according to CLI `lsclosurebattery` command
- Fan events

If the upgrade cannot be resumed or you have other alerts which cannot be cleared, contact IBM Support. Upon completion of upgrade to 1.1.2.7, a RAID certify will run to verify RAID stripes. This process takes a few hours depending on workload and can impact performance during this time.
