IBM FlashSystem 720 and IBM FlashSystem 820

Firmware Version 6.3.2, patch 7

Release Notes

August 28, 2017

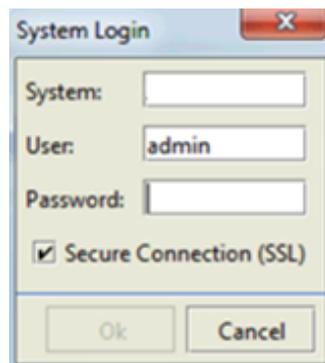
Figure 1. Logging into the system.

8. To upload the patch using the web interface, use one of the following methods:
 - a. Point a browser at the unit IP address or hostname.
 - i. Log in using admin group level permissions or higher. You must uncheck the “Secure Connection (SSL)” check box in order to login and upload the patch. See the figure below for reference.

Note: Unchecking the SSL check box in order to log in through the GUI is only applicable to patch 5 and is a temporary workaround.
